**St. Brigid's Church
Drumkeeran
Co. Leitrim**

Renovation of Roof and Bell Tower

Doc ref: 14043-AH2

3.0 CONDITION SURVEY.

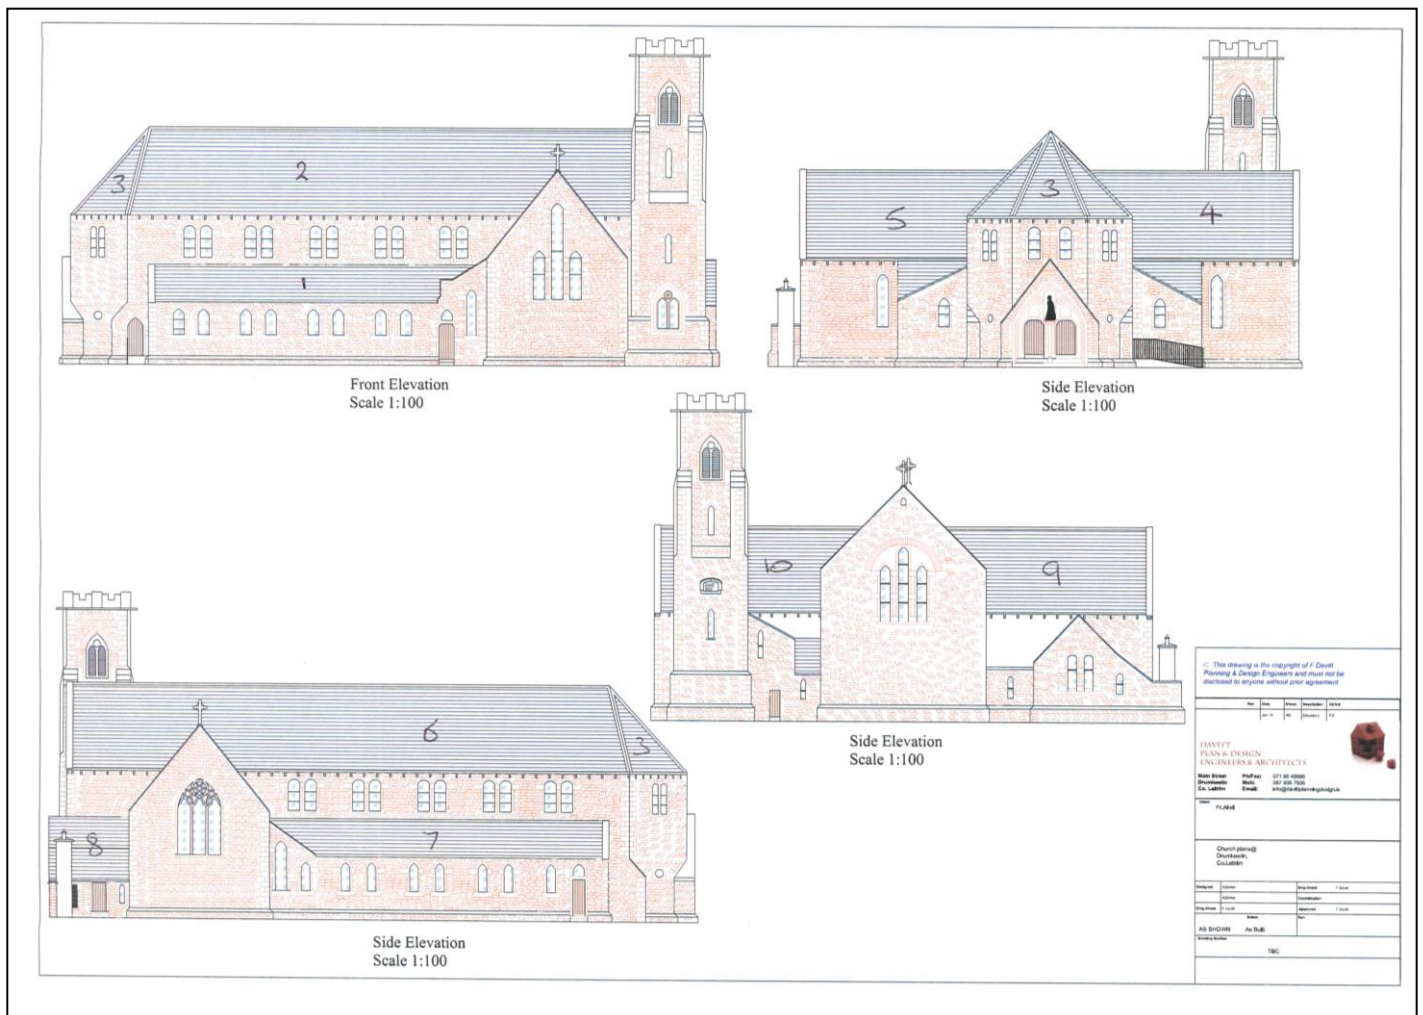
To assist with recording and reporting we have broken the roof into 10 sections as per the below diagram.

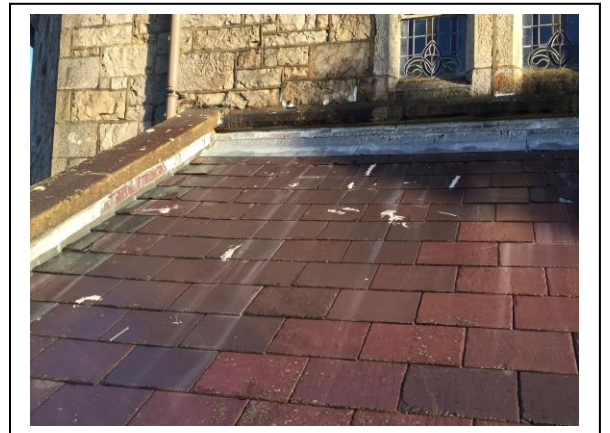
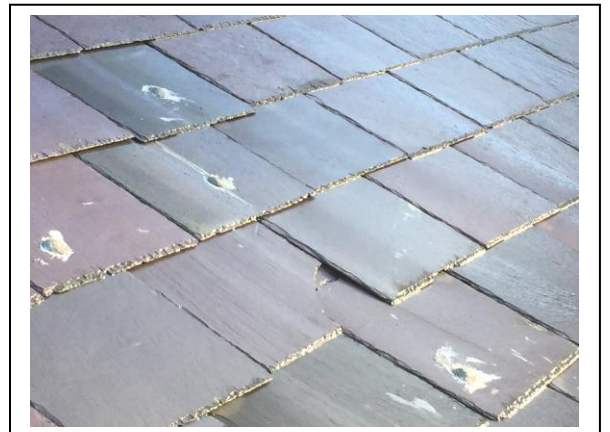
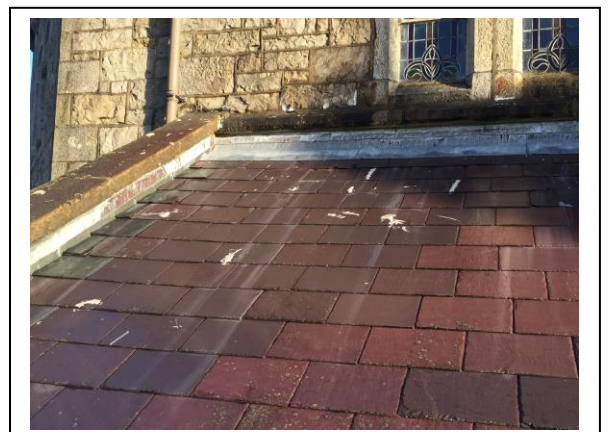
Roof No 1.

Roof 1 is in quite a poor condition with a variety of repairs of variable standards, we also noted a number of broken slates, or slates with fissure or hair line cracks. It was also noted that the darker blue slates where much thinner and many have cracked.

We also noted that a substantial number of slates have been glued and/ or doweled into place and therefore this section of roof has been subjected to substantial repairs over the years.

It was also noted on a number of locations that slates have slipped and this would suggest that nail corrosion is becoming an issue.

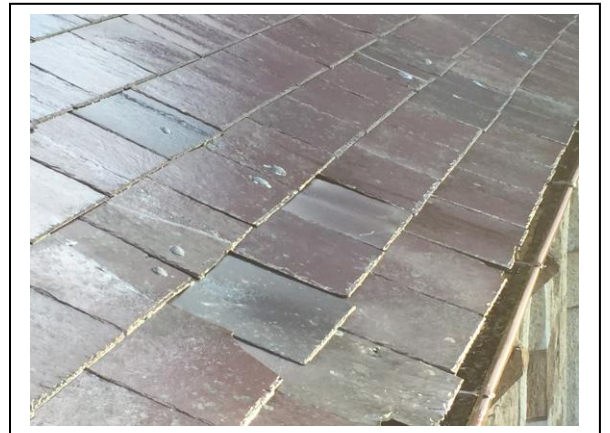
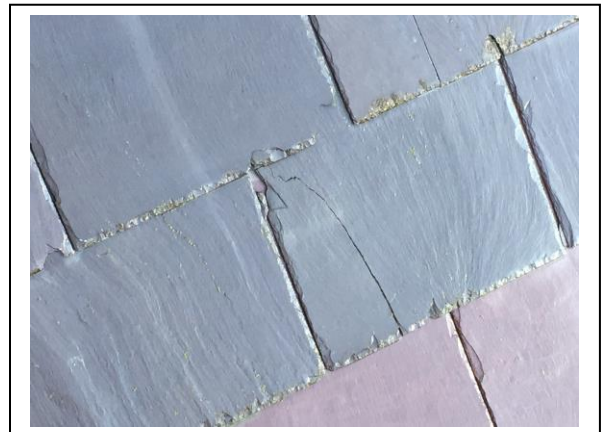
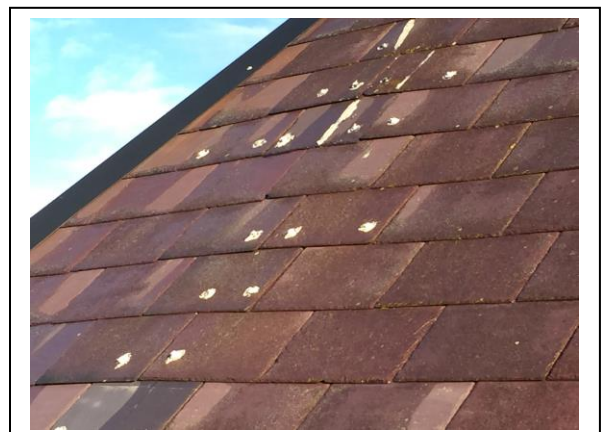
Roof No 2.

The eastern end of Roof 2 is in reasonably good condition and may have been repaired substantially when the octagonal entrance porch was repaired, however the western end is in quite a poor condition with a variety of repairs of variable standards, we also noted a number of broken slates, or slates with fissure or hair line cracks.

We also noted that a number of ridge tiles are missing and that the pointing has broken away.

It was also noted on a number of locations that slates have slipped and this would suggest that nail corrosion is becoming an issue.

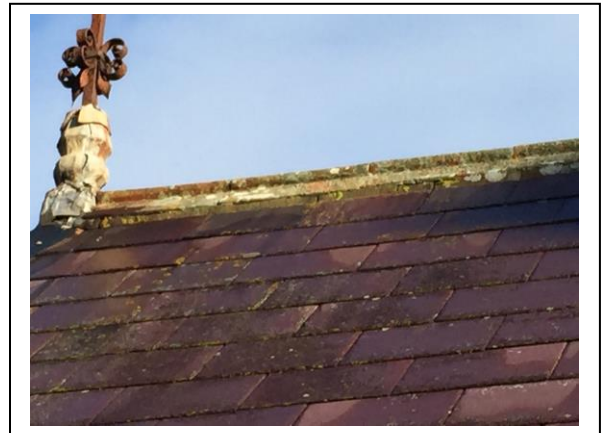
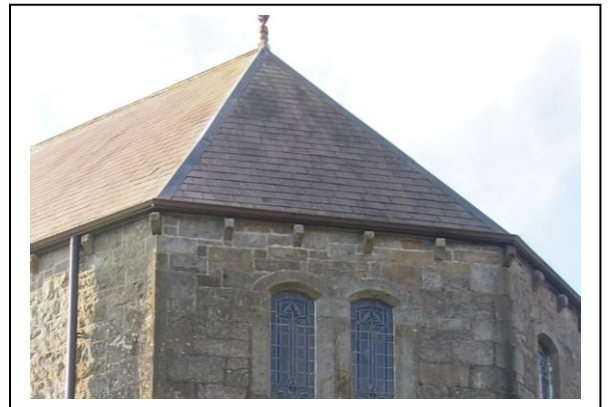
Roof No 3.

Roof 3 is in reasonably good condition and is thought to have been repaired substantially .

It is noted that the hips have been covered in aluminium tile trim which is inappropriate. Also finial is in poor condition and flashing around it appears to be defective.

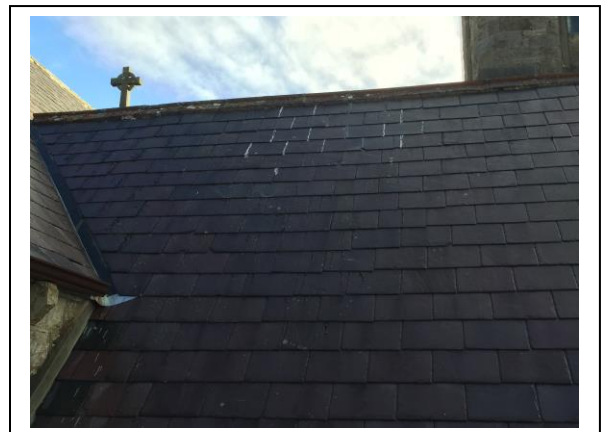
Roof No 4.

Roof 4 is in very poor condition and looks to have been repaired substantially with inappropriate techniques. There is evidence Butyl rubber having been used to seal slates and a number of slates have been doweled. We also noted a number of cracked slates and slipped slates which also suggest that the nails may be corroded. The lead valleys and abutments also require attention.

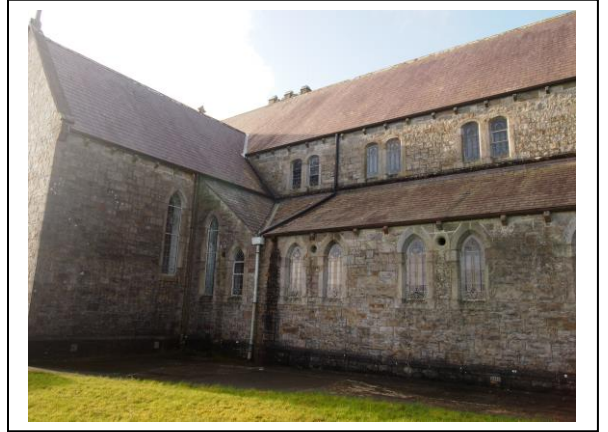
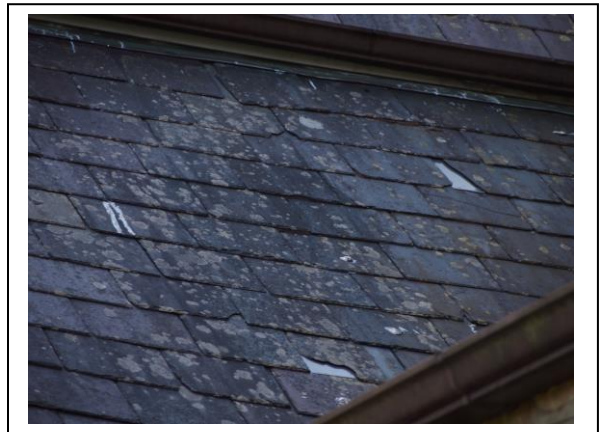
Roof No 5.

Roof 5 is in very poor condition and looks to have been repaired substantially with inappropriate techniques. There is evidence Butyl rubber having been used to seal slates and a number of slates have been doweled. We also noted a number of cracked slates and slipped slates which also suggest that the nails may be corroded. The lead valleys and abutments also require attention.

The lower portion of this roof is in particularly poor condition with a substantial number of broken/ cracked slates.

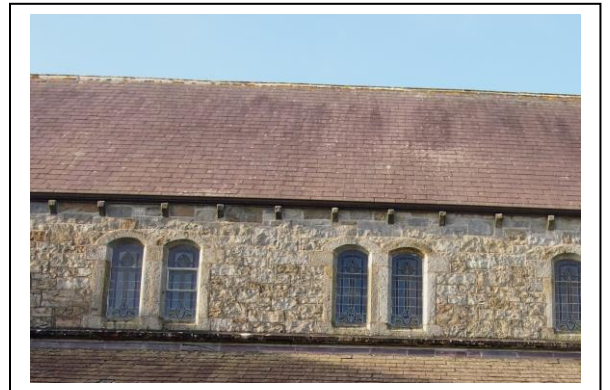
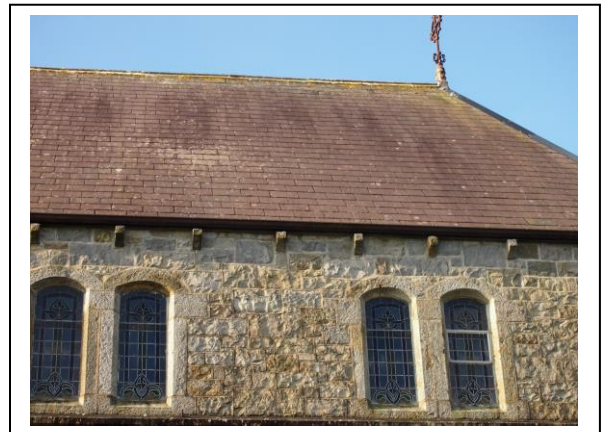
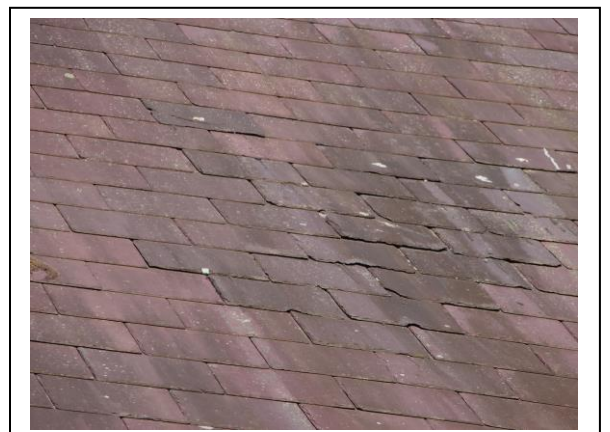
Roof No 6.

The eastern end of Roof 6 is in reasonably good condition and may have been repaired substantially when the octagonal entrance porch was repaired, however the western end is in quite a poor condition with a variety of repairs of variable standards, we also noted a number of broken slates, or slates with fissure or hair line cracks.

We also noted that a number of ridge tiles are missing and that the pointing has broken away.

It was also noted on a number of locations that slates have slipped and this would suggest that nail corrosion is becoming an issue.

There is a large repair evident in the centre of the roof where the slates have been reattached with aluminium clips.

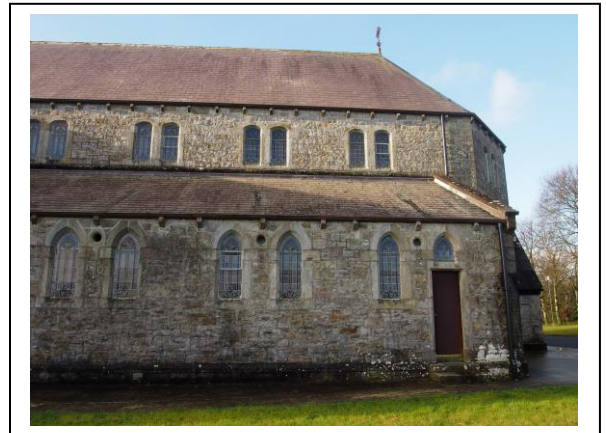
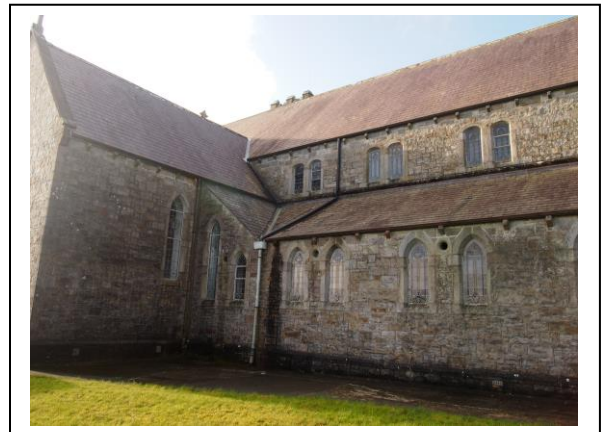
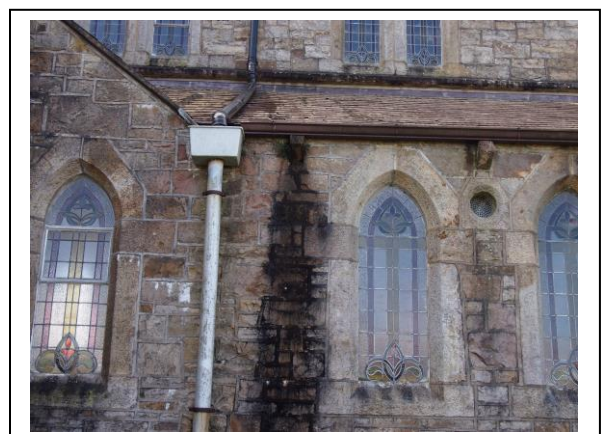
Roof No 7.

Roof 7 is in quite a poor condition with a variety of repairs of variable standards, we also noted a number of broken slates, or slates with fissure or hair line cracks. It was also noted that the darker blue slates where much thinner and many have cracked.

We also noted that a substantial number of slates have been glued and/ or doweled into place and therefore this section of roof has been subjected to substantial repairs over the years.

It was also noted on a number of locations that slates have slipped and this would suggest that nail corrosion is becoming an issue.

There are considerable issues with the rain water goods which are resulting staining and damp ingress.

We also note the existence of iron brackets which are located along the abutment with the naïve which would suggest that a gutter was originally installed at this location. At sometime this was removed and the roof of the naïve now discharges onto the aisle roof increasing the volume of water .

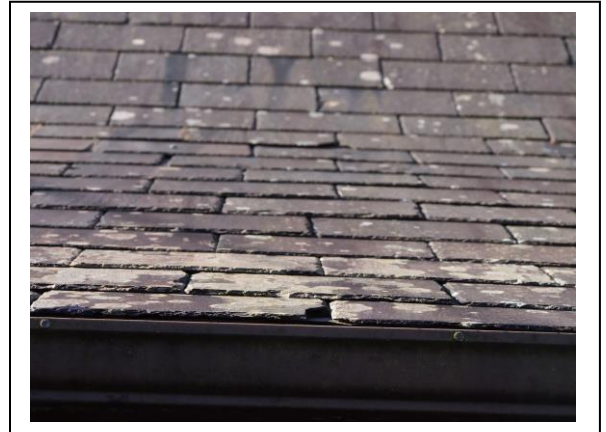
Roof No 8.

Roof 8 is in very poor condition with a number of broken slates, however the main issue here is the roof pitch which is too low for natural slate.

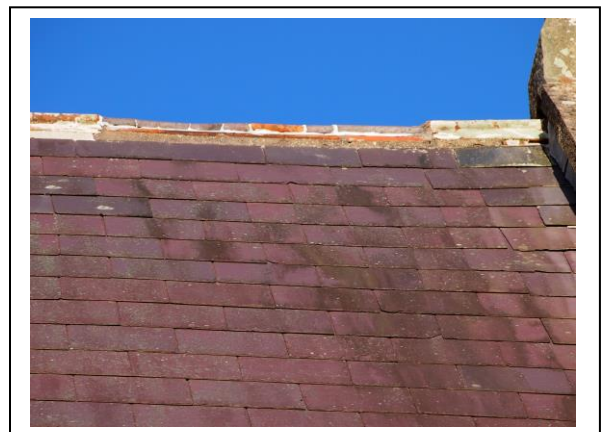
Roof No 9.

Roof 9 is in very poor condition and looks to have been repaired substantially with inappropriate techniques. There is evidence Butyl rubber having been used to seal slates and a number of slates have been doweled. We also noted a number of cracked slates and slipped slates which also suggest that the nails may be corroded. The lead valleys and abutments also require attention.

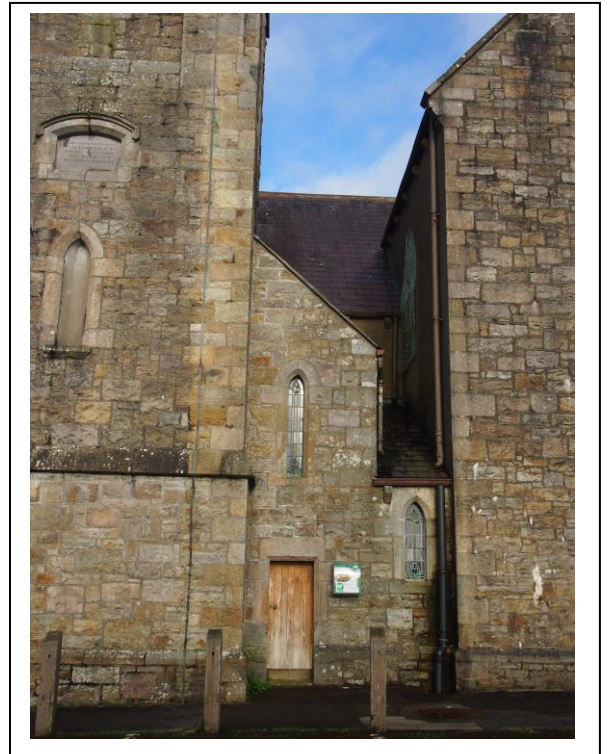
Roof No 10.

Roof 10 was not accessible from the teleporter nor is it very visible from the ground being located behind the belfry, however there are signs of poor repairs and therefore we can assume that the roof is in similar condition to the adjoining roofs. It would also be important to inspect the lead flashings & abutments in this locality as there are a lot of interfaces.
